# Manhole Inspection Summary

## Manhole # S11AA1010MH

Insp Date: **1/23/09 9:09 AM**

**Location** Address: **3319A DOLFIELD AVE**

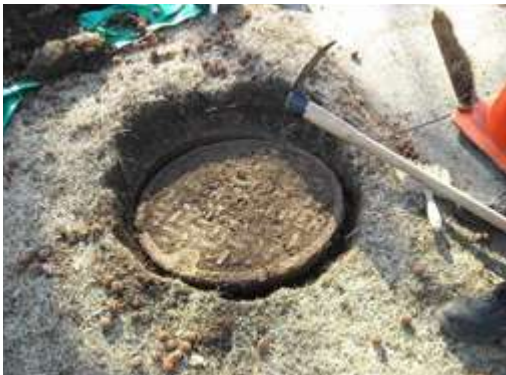
OPENED USING 16LB MAUL

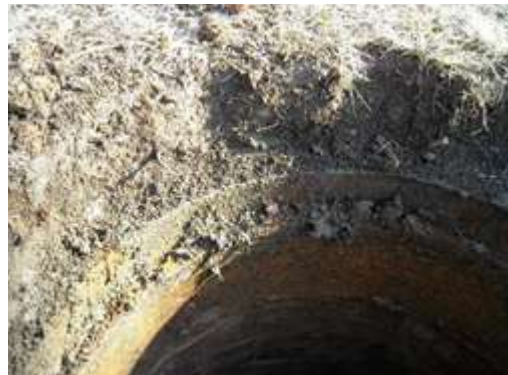
EVIDENCE OF INFLOW DUE TO SHEETING - BELOW GRADE

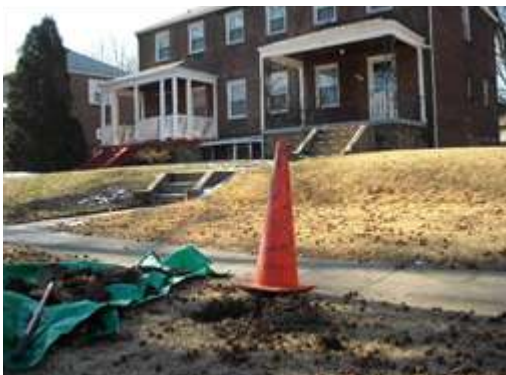
LOCATED BELOW GRADE

**Cover** Shape: **Circular** Diameter: **24** (in.) Length: (in.) Dist A/B Grade: **-6** (in.)

REMOVED 6" OF DIRT FROM ABOVE MH LID.

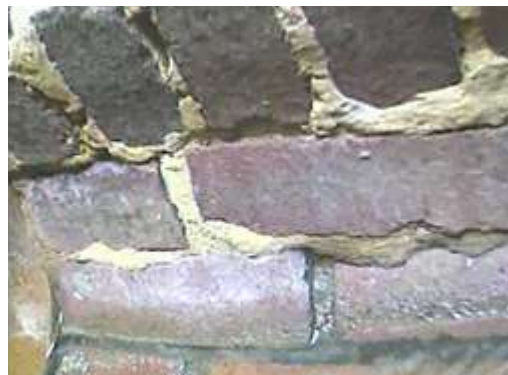
Defect 3

Condition: ☐ Sound ☐ Cracked ☐ Root Intrusion ☒ **Deteriorated** ☐ Leaks ☐ Debris

SOME DETERIORATION OF MORTAR IN CHANNEL

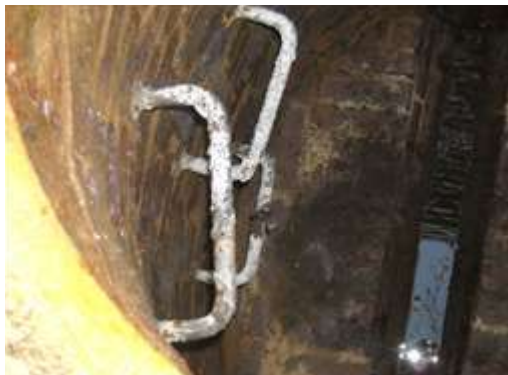
Defect 2

**Steps** Count: **3** Missing: **0** ☒ **Corroded**

3 STEPS SHOWING SIGNS OF  
CORROSION

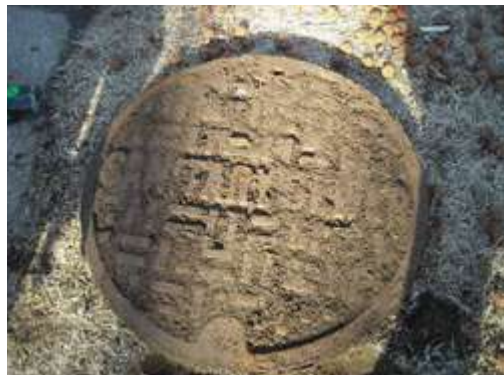
Defect 1

Type: **Sanitary** Condition: **Worn** Cover Material: **Cast Iron**

WORN LID

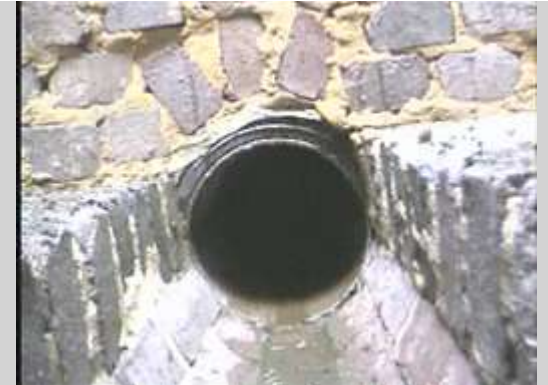
12 O'Clock Outflow

Pipe Height: **8.4** (in.) Rod and Bar (Angled)  
Pipe Material: **Clay** ☐ Pipe Lined  
Invert Depth: **7.15** (ft.) Flow Characteristics: **Slow**  
Deposits: ☒ None ☐ Mud ☐ Sludge ☐ Debris ☐ Grease  
Silt Depth: (in.) Deposits Extent:  
Infiltration: **None** Pipe Seal Cond: **Sound**

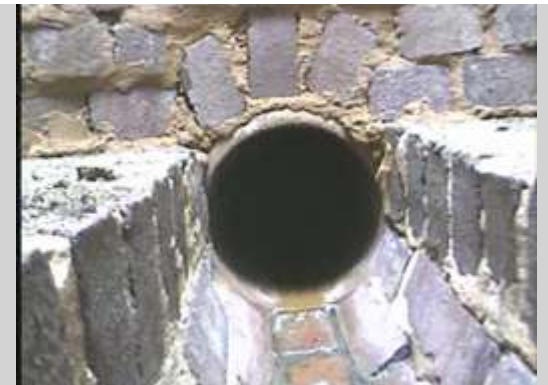
6 O'Clock Inflow

Pipe Height: **8.4** (in.) Rod and Bar (Angled)  
Pipe Material: **Clay** ☐ Pipe Lined  
Invert Depth: **7.01** (ft.) Flow Characteristics: **Slow**  
Deposits: ☒ None ☐ Mud ☐ Sludge ☐ Debris ☐ Grease  
Silt Depth: (in.) Deposits Extent:  
Infiltration: **None** Pipe Seal Cond: **Sound**
